# Diagnosis Report

Report ID · E928661C  
[www.foxscan.in](http://www.foxscan.in)

Prepared For  
Urbanroof

### Stair Case Passage Area

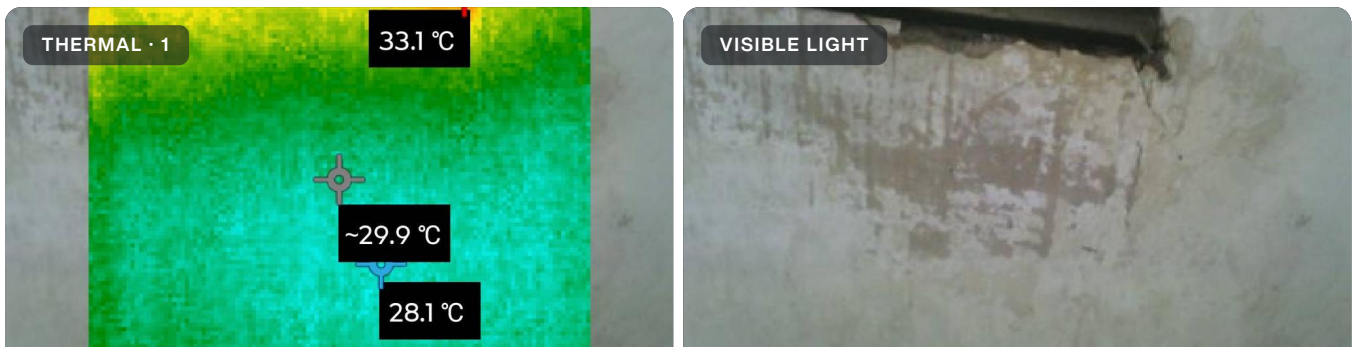
Hotspot 33.1°C

Coldspot 28.1°C

Differential  $\Delta T$  10.1°C

The cooler band (blue-green) traces moisture held behind the surface, where evaporation lowers the temperature. A 10.1°C differential against the surrounding wall confirms active sub-surface dampness not visible to the naked eye.

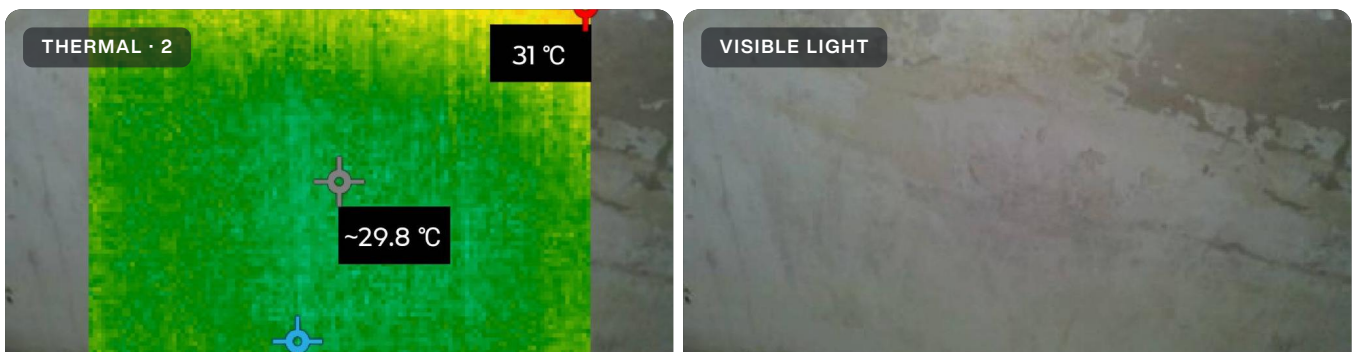
Hotspot 32.8°C

Coldspot 27.8°C

Differential  $\Delta T$  9.8°C

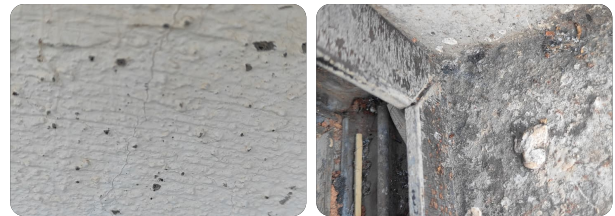
## SOURCE · PROBABLE ORIGIN

*Origin: these is the external wall*

The three Group C source-side photos focus on the external wall — the weather-facing facade plaster of the staircase passage. The evidence shows deteriorated/cracked external plaster and tired surface paint that no longer sheds water, allowing rain to be absorbed into the masonry. There are no signs of a discrete plumbing or trap source; the ingress is across the porous facade face. The external wall is therefore confirmed as the source surface.

Rainwater enters through the cracked and weathered external facade plaster of the staircase passage wall seen in the Group C source photos, where the failed paint film and open plaster cracks let moisture soak into the masonry. It then migrates through the wall thickness, which is confirmed by the broad, high- $\Delta T$  (9.8–11.2°C) cool field across the wall in the Group A thermal frames. This sub-surface moisture finally surfaces on the impact face as the peeling paint, damp patches and efflorescence documented in the Group B photos. Severity is moderate because the damage is active and spreading but still confined to surface plaster without structural cracking; left untreated the salts and damp will keep delaminating plaster and can reach adjacent finishes. The source is the penetrating external facade wall; the stained interior wall face is only the symptom.

**Fill the external-wall cracks & re-plaster**

Open out the cracks in a V-groove, fill with polymer crack filler, and re-plaster the affected patches flush so the face is sound before the waterproof coat.

**Renew the external waterproof coating**

Clean the facade, fill hairline cracks, and apply a fresh exterior waterproof coating so wind-driven rain cannot penetrate the porous surface.
